Technical Report ARAED-TR-93004

**XM898 PROJECTILE 155-mm SADARM PACKAGING
DESIGN AND ENGINEERING TEST REPORT**

Mark P. Nitzsche

April 1993

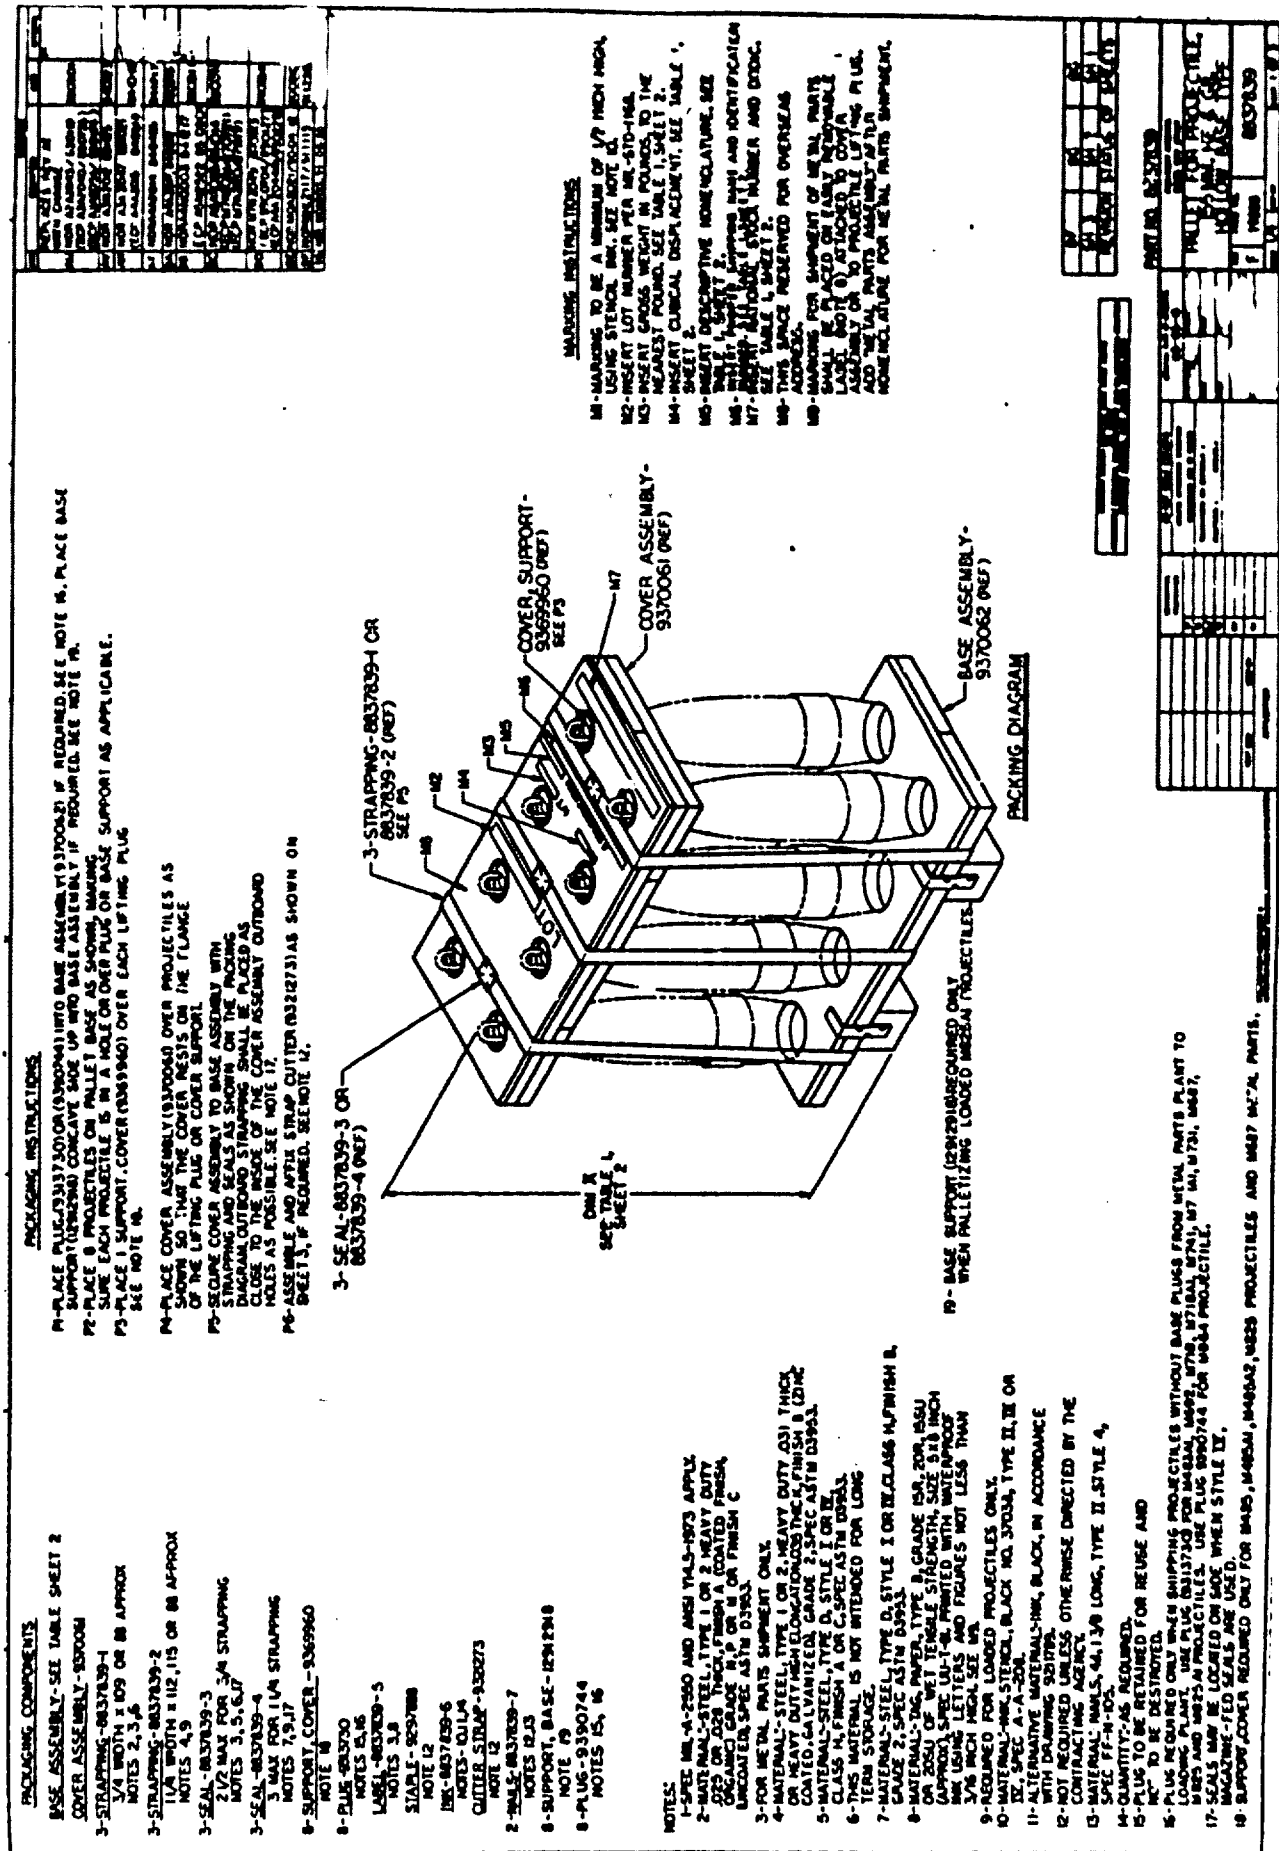
Figure 7. Wood pallet base after testing

As previously stated, the wood pallet sustained severe damage during secured vibration in the vertical axis at ambient. This testing was done in accordance with the schedule originally required by the test plan. No problems were encountered during vibration in the longitudinal and transverse directions. However, while testing in the vertical axis several of the projectiles broke through the pallet cover. In addition, the pallet base was severely splintered.

During secured vibration testing at -65°F, the bottom rims of the projectiles again cut into the base of the wood pallet. However, the depths of the grooves were only about 1/8 in., and there remained substantial clearance (approximately 1/2 in.) between the grommets and the pallet base. The other damage sustained by the wood pallet was in the cover. One lifting plug hole was elongated and another splintered in the area of the chamfer. At the completion of secured vibration at -65°F, there was no evidence of damage to the projectiles, and they remained consolidated in the wood pallet.
